D. 2
PRELIMINARY ASSESSMENT/
VISUAL SITE INSPECTION

AMEROCK CORPORATION, A SUBSIDIARY
OF THE NEWELL GROUP
ROCKFORD, ILLINOIS
ILD 000 806 190

FINAL REPORT

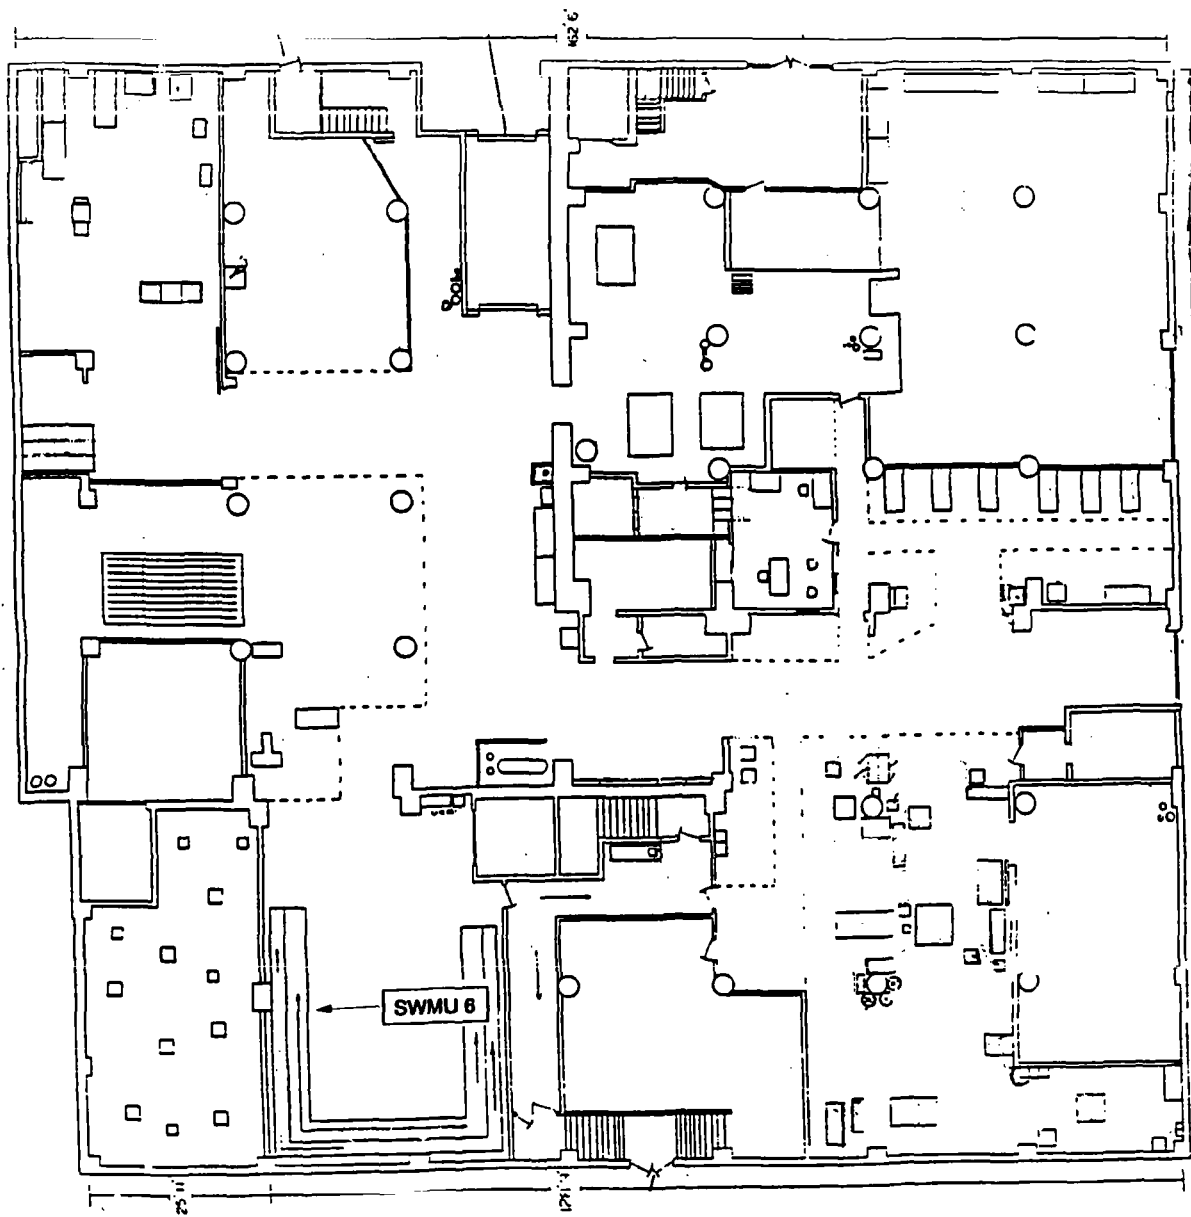
Figure 3
FACILITY LAYOUT/SWMU LOCATIONS
SECOND FLOOR

6. Spent Battery Storage Area

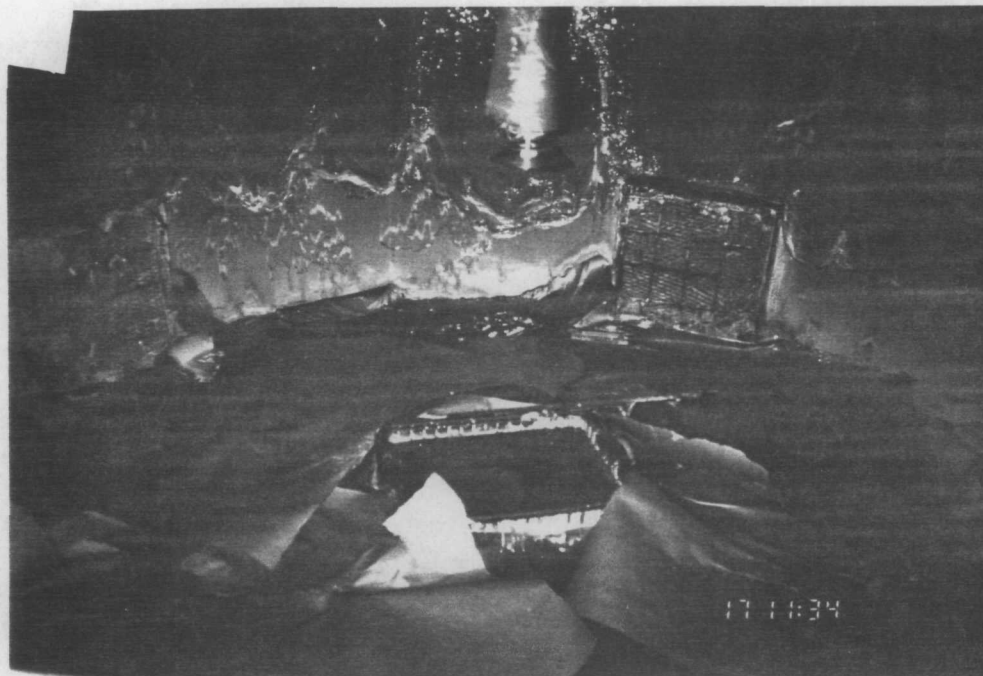
Photograph No. 1

Description: This is the electrostatic paint spray booth where waste MEK (F005) is accumulated in a 5-gallon pan. This is on the sixth floor.

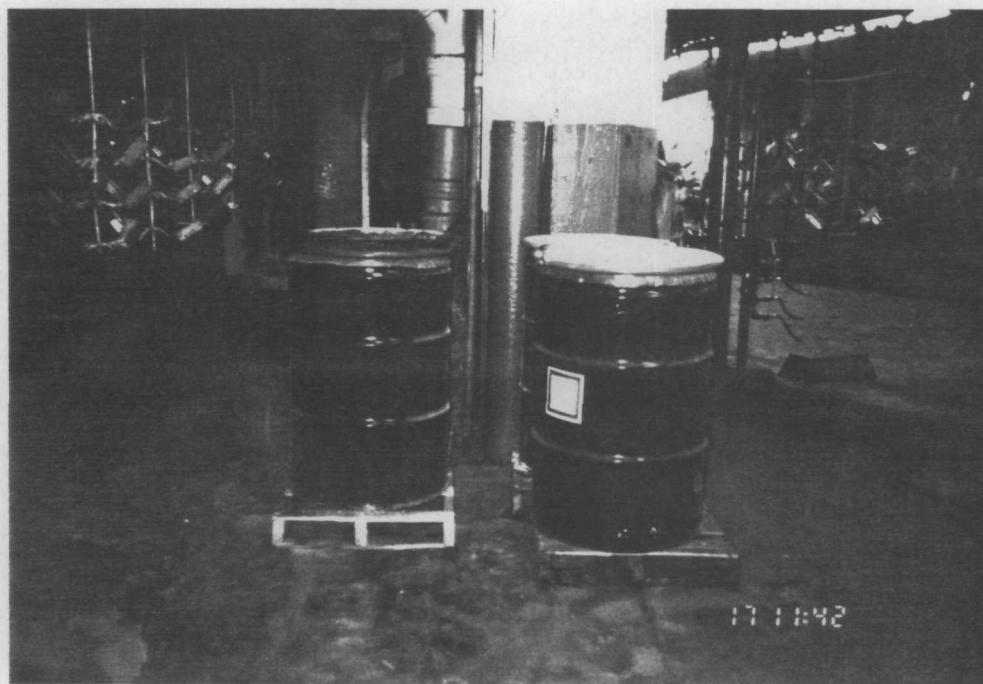
Photograph No. 2

Observations: The area in the northeast corner contained two 55-gallon drums during the VSI. One drum was nearly empty and the other drum was half full. There were no cracks in the floor and the drums were properly sealed. The area in the southeast corner contained one 5-gallon pan. No evidence of release was noted.

Description: On the left is the accumulation of hazardous chromate waste. The two drums on the right are nonhazardous phosphate and cleaner waste.

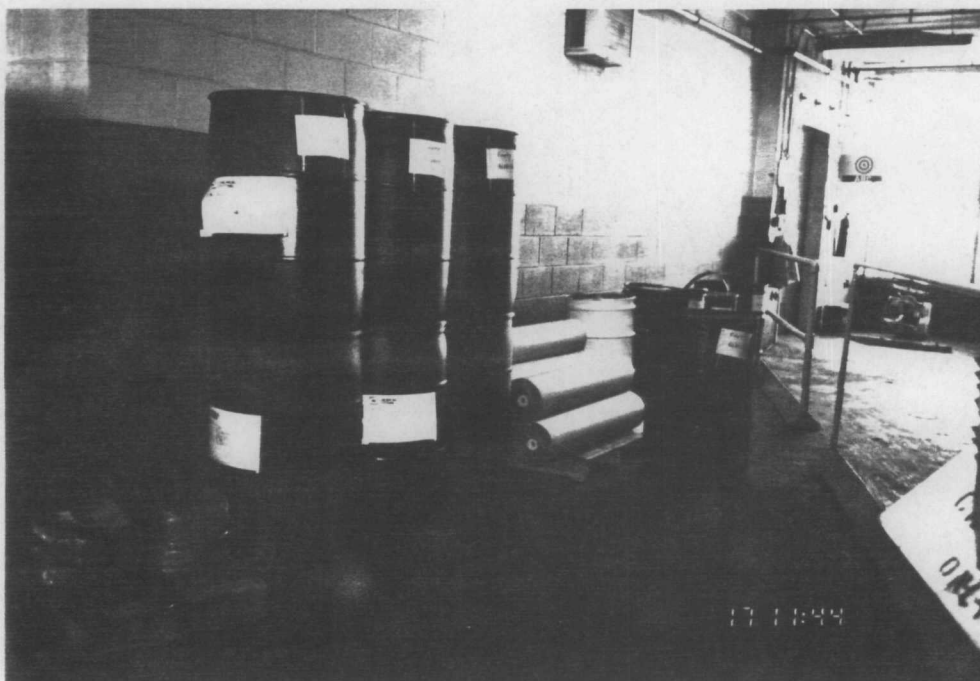
Photograph No. 4
 Orientation: North
 Description: This is a RCRA-closed drum storage area. It currently stores empty drums and rolls of paper.

The unit contained empty drums and about ten rolls of paper. No evidence of a release was noted.

Location: SWMU 8
 Date: 12/17/91

Recommendations: RAI recommends no further action at this time.

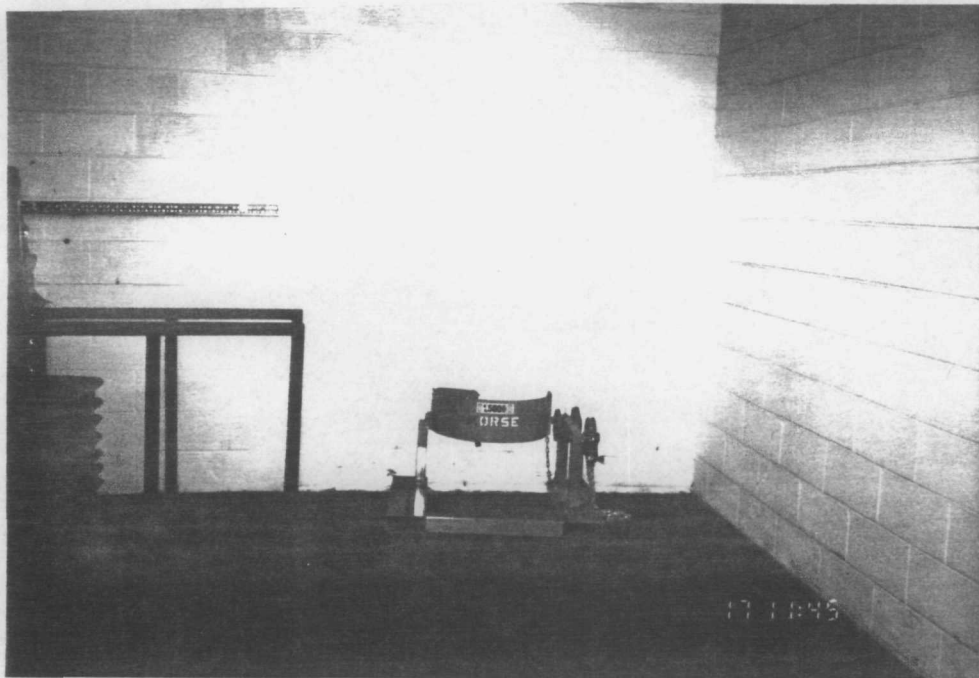
Photograph No. 5
 Orientation: North
 Description: This is a RCRA-closed drum storage area.

Observations: The unit contained nothing. No evidence of release was noted.

Location: SWMU 7
 Date: 12/17/91

Recommendations: RAI recommends no further action at this time.

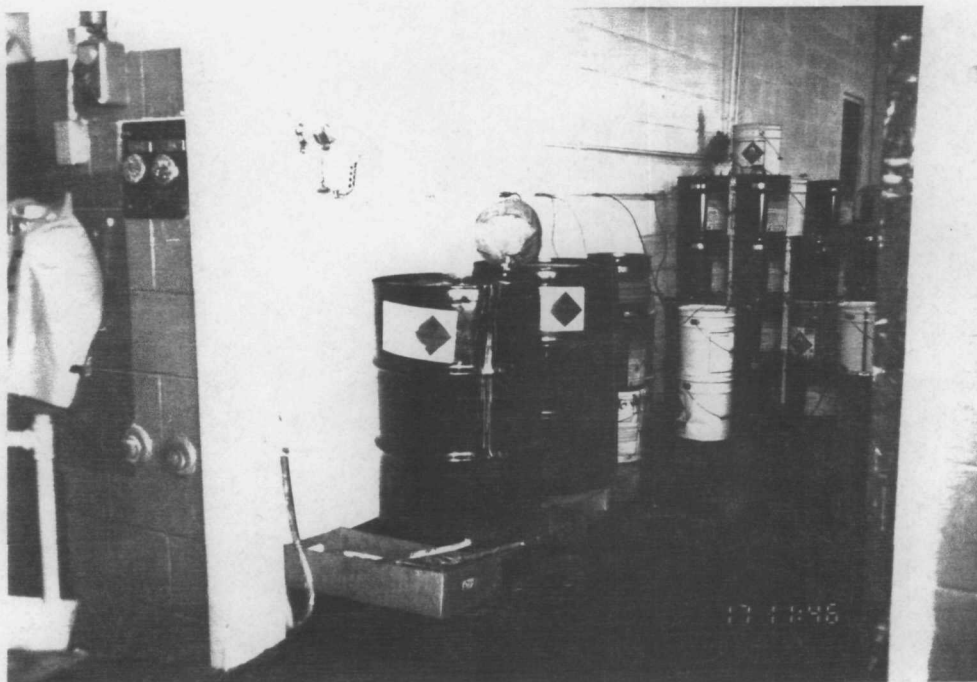
Photograph No. 6
 Orientation: West
 Description: This is the Hazardous Waste Container Storage Area. It also stores product paint.

Release Controls:	No floor drains are in the area. A berm is located at the entrance of the room. There are no visible cracks in the floor.
History of Documented Releases:	No releases from this unit have been documented.
Observations:	During the VSI, numerous product paint containers and many 55-gallon drums were observed in the area. There was some staining on the floor of the unit.

Conclusions: This unit stores hazardous waste for less than 90 days on the sixth floor. The unit has a concrete floor with a berm at the entrance of the room. The room is kept closed by a metal door.

Location: SWMU 5
 Date: 12/17/91

Recommendations: RAI recommends no further action at this time.

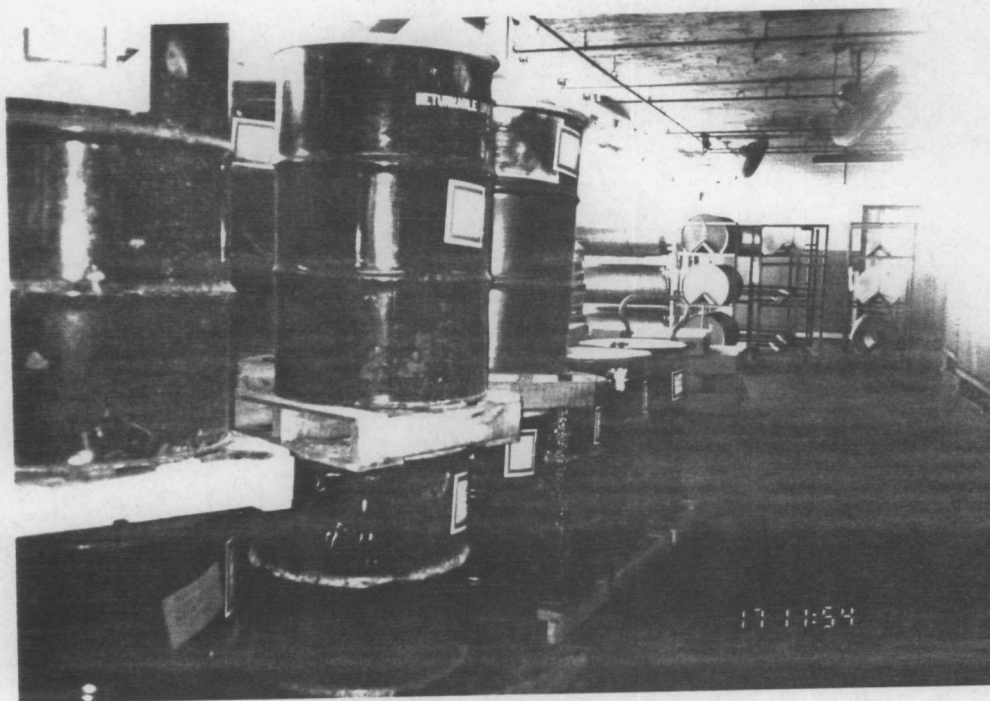
Photograph No. 7

Observations: The unit contained approximately twenty-three 55-gallon drums during the VSI. All drums were properly sealed and no cracks in the pavement were visible. No evidence of release was noted.

Location: SWMU 2

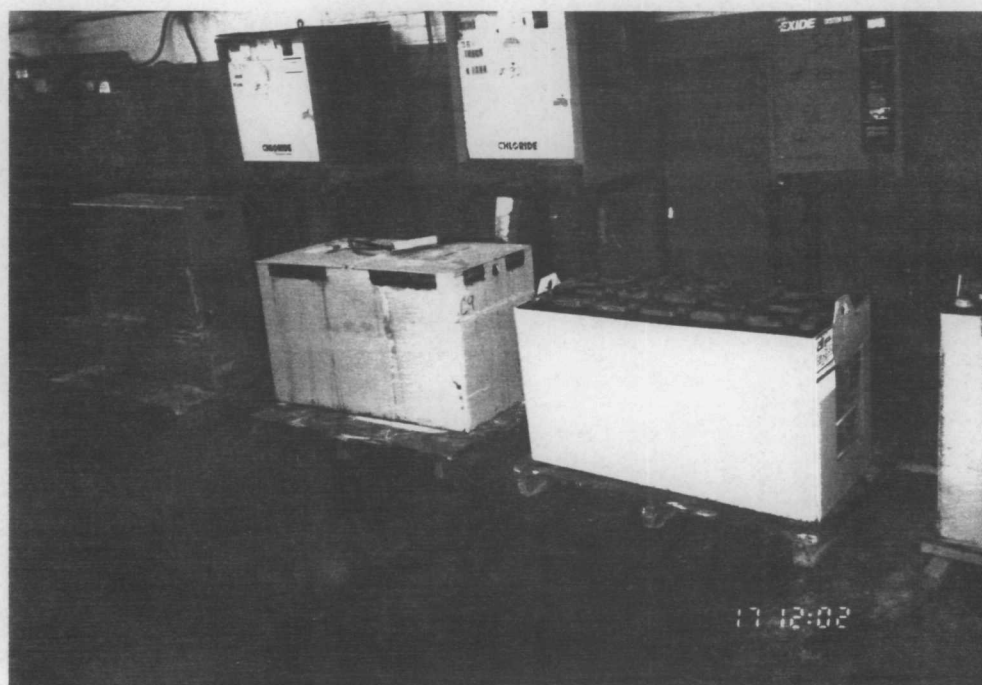
Photograph No. 8

Observations:	At the time of the VSI, the area contained four batteries stored on wooden skids waiting to be recharged. No evidence of release was noted.
---------------	---

Location: SWMU 6

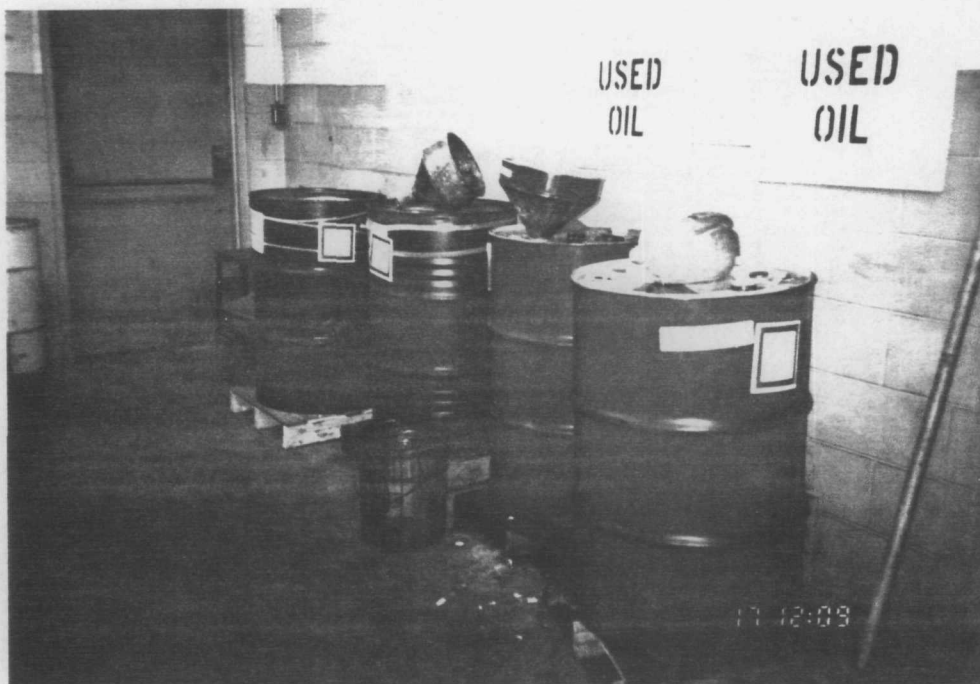
Photograph No. 9
 Orientation: Southeast
 Description: This is where waste oil is accumulated.

At the time of the VSI, RAI observed waste oil on the floor the the Waste Oil Drum Storage Area (SWMU 3). RAI recommends that the waste oil be cleaned up. RAI recommends no other action for this facility at this time.

Location: SWMU 3
 Date: 12/17/91

Recommendations: RAI recommends that released waste oil that accumulates around the plugged floor drain be cleaned up.

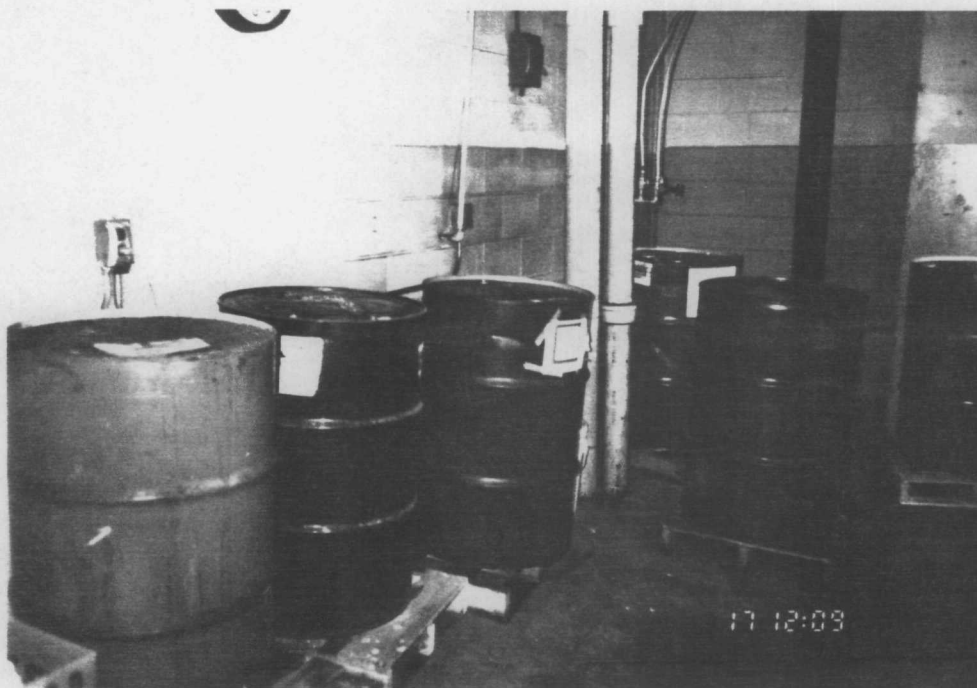
Photograph No. 10
 Orientation: Northwest
 Description: These are five full waste oil drums waiting to be shipped out. This is located on the second floor.

Location: SWMU 3
 Date: 12/17/91
